ST NICHOLAS CHURCH, STEVENAGE  
ASSESSMENT OF HERITAGE SIGNIFICANCE

March 2018

ARTEMIS HERITAGE

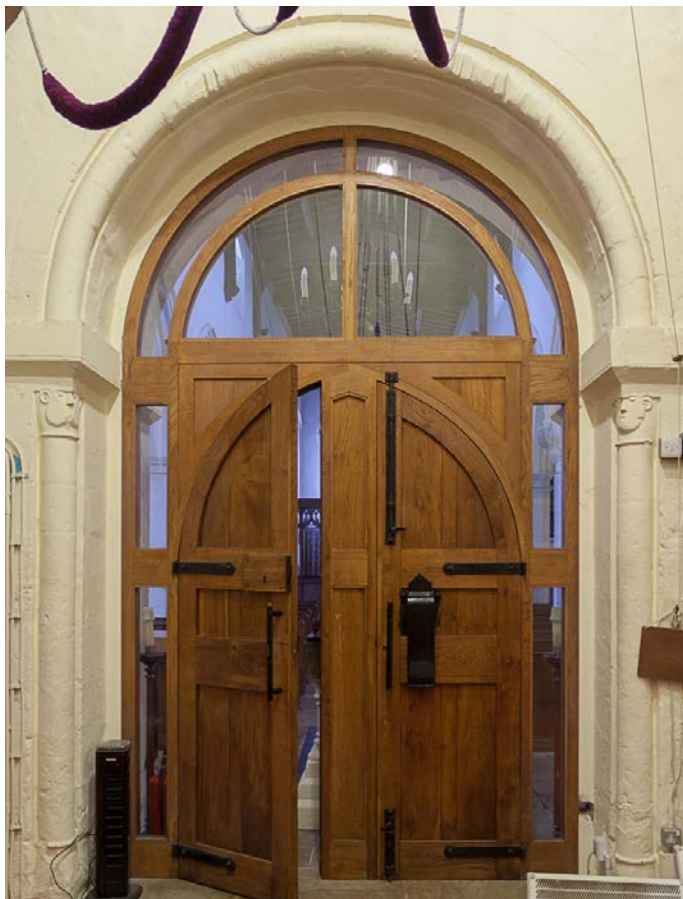
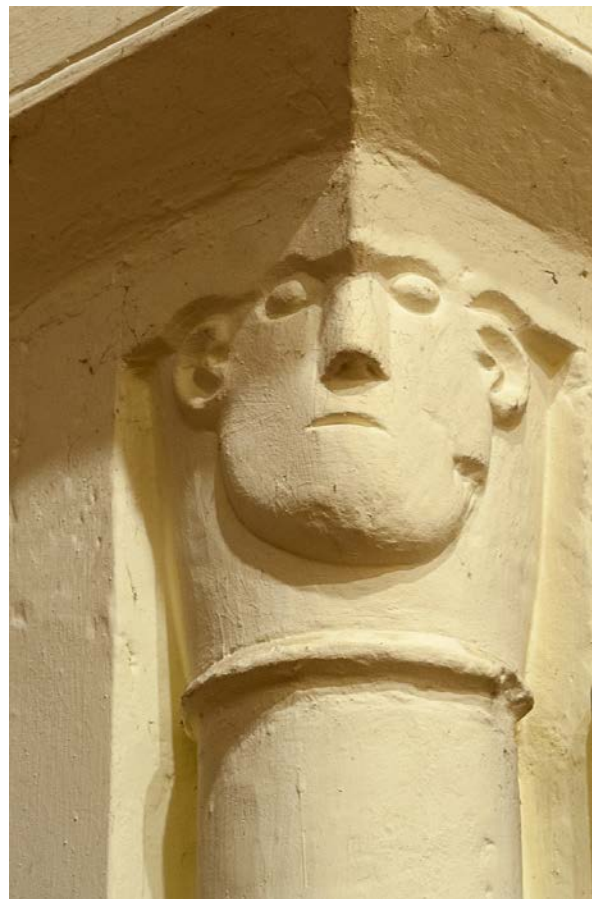
*Below left: west elevation of tower arch with re-located Nicholson doors. Below right: capital on western tower arch*

The oldest part of the existing structure is the west tower. This would originally have been constructed without buttresses. There are two small Romanesque style windows on each of the north and south sides, though only the lower one on the north side has the appearance of retaining any original masonry. The west door has had a substantial part of its round-headed arch renewed but it retains its original twelfth century capitals. Internally the tower arch springs from simple impost blocks on the east (church) side but is decorated with a roll moulding and shafts with mask-like capitals on the west (tower) side.

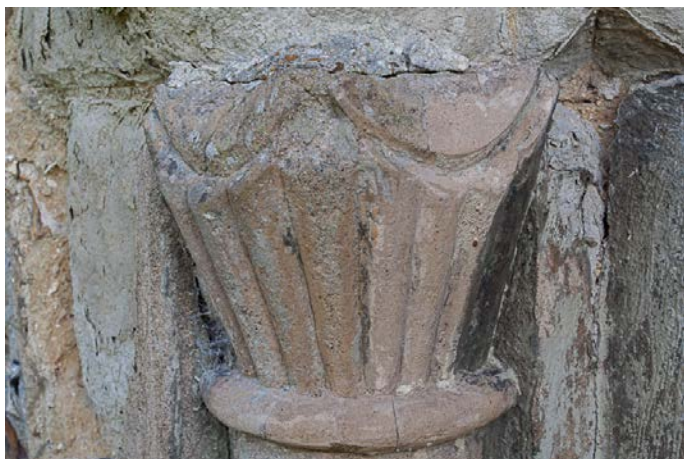
*Capital supporting arch over west door into the tower*

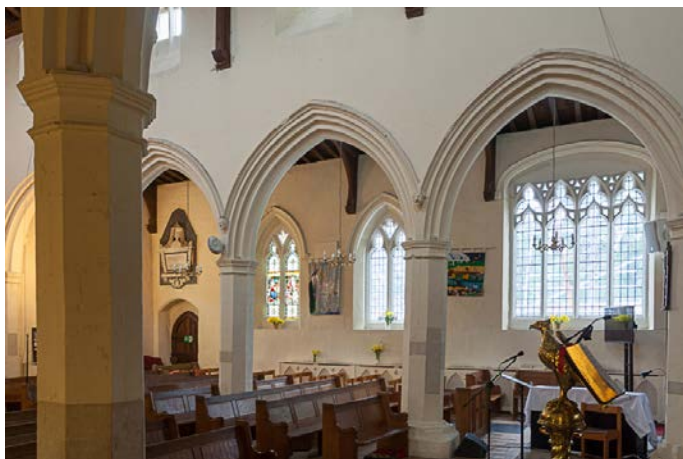
*View across nave towards north aisle*

does not seem to relate to any internal feature. The arches of the arcade are relatively shallow, moulded in three orders, the inner one with a hollow chamfered profile. The clerestory above consists of two cinquefoil-cusped lights (where they survive) within a depressed arch with a steeply raking cill. The arcade arches, capitals and the clerestory windows are part of an extensive fifteenth-century remodelling of the church (see below).

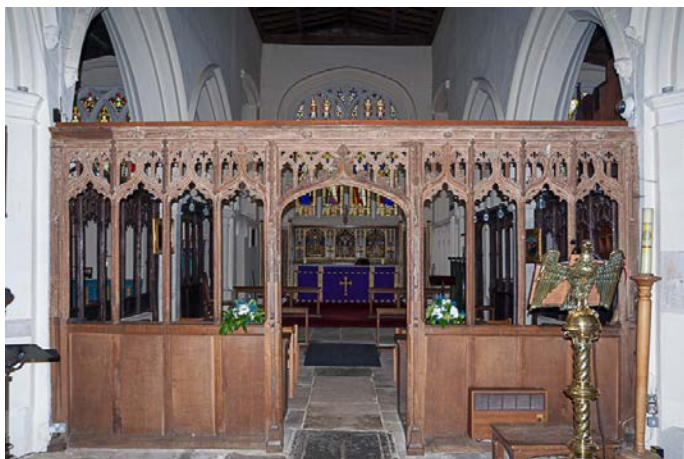
Chancel screen viewed from the west

The doorway is in the form of a depressed four-centred arch with an ogee label. Above the arch the

spandrels are filled with more window designs with perpendicular reticulated tracery but on a slightly larger scale and with more elaborate cusping.

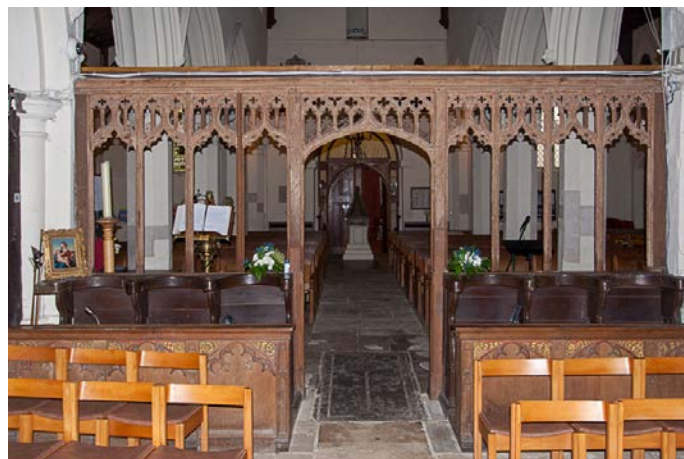
Chancel screen viewed from the east

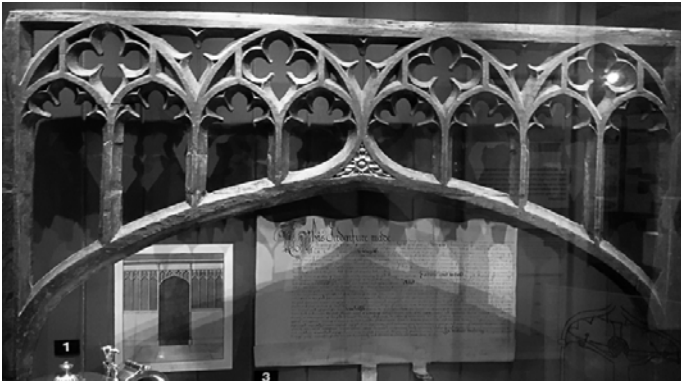
*Fragment of medieval screen held in Stevenage Museum*

The design of this arch, with the perpendicular reticulated tracery is almost identical to the head of the doorway on the chancel screen. The Oldfield watercolour shows that this screen is a simplified version of the chancel screen, there are four lights on either side

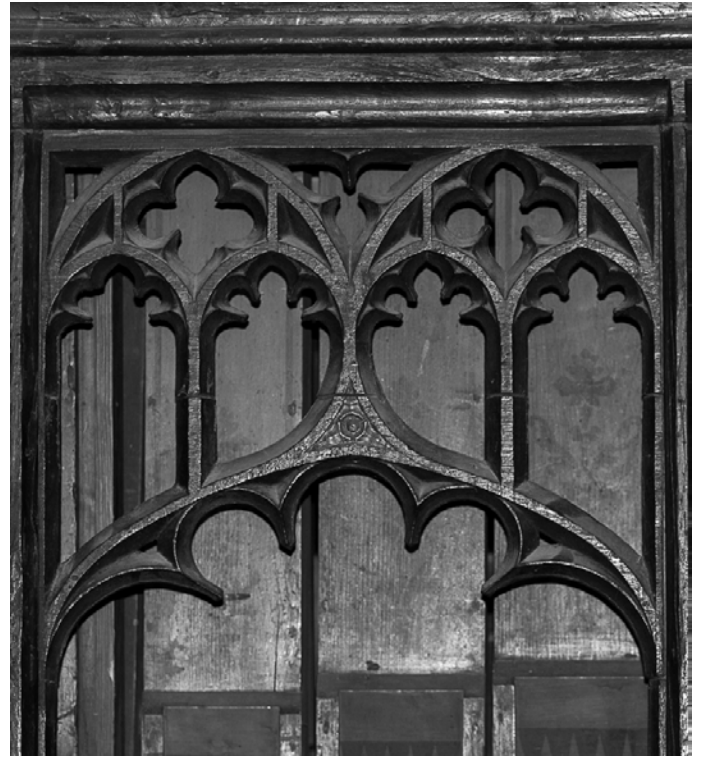
*Detail of tracery on western parclose screen on south side of chancel*

The dado of these flanking screens has been raised and a raked ledge for books attached on the chapel sides. These alterations probably date from the eighteenth century when the screens appear to have been used to form private 'box' pews. These screens, unlike the chancel and museum screen, are stained with a dark brown paint which serves to disguise any anomalous repairs. The screens do not appear to fit snugly into their current location with the gap between the ends of the screen and the column and respond of the arch being crudely filled with timber. This infilling does not indicate that the screens were not designed for their current location. Nicholas Cholwell's Memorandum Book records that in 1841 "The old screens were also lowered two feet to the present, and apparently original position." Nicholson subsequently lowered the floor again in his restoration in 1913. If one imagines the screens nearly three feet higher then the cornice would encounter the curve of the arch and indeed one can see that the screens were first adjusted to accommodate the arch and then patched when subsequently lowered.

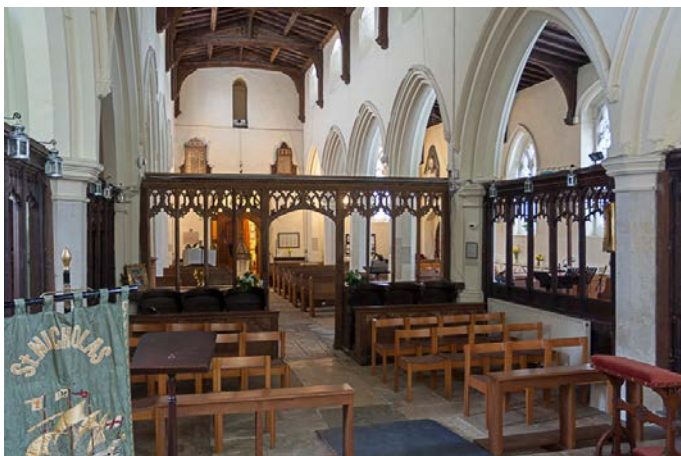
*Below: chancel and western parclose screens from the east*

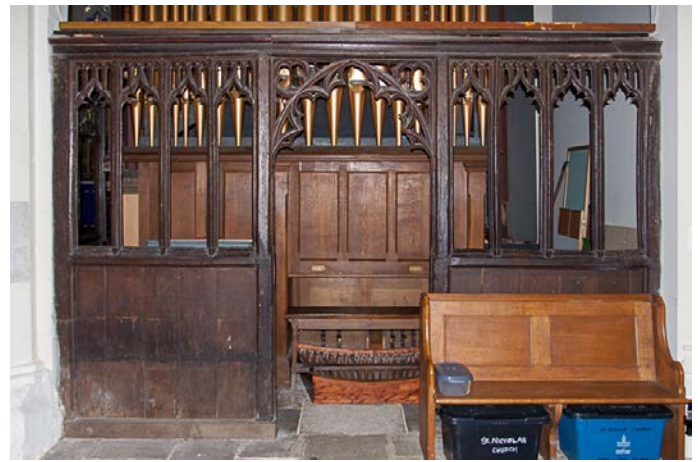
*South chapel screen*

The upper parts of the screens on either side of the doorway are each divided into four cinquefoil cusped ogee lights. The spandrels, between the extrados of the arch and the square enclosing frame, are filled

The screen at the entrance to the Trinity Chapel may once have been located at the entrance to the Lady Chapel. It seems to have been substantially modified. The door is missing, it is mounted back to front, the cornice is not original and we suspect that the arch over the doorway is not in its original location. Never-the-less this screen has **high significance**. Its design is related to the two eastern parclose screens, the southern one of which was used for a period of almost 30 years to screen a choir vestry in the Lady Chapel. These too are of **high significance**.

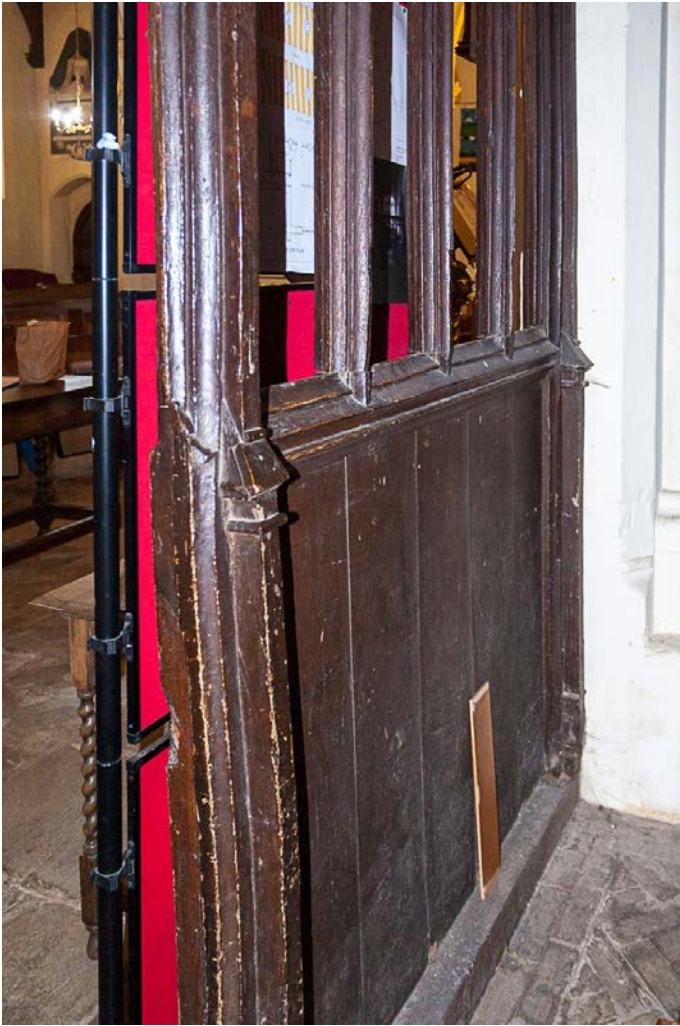
East face of south chapel screen, displaying buttresses that would normally face the body of the church

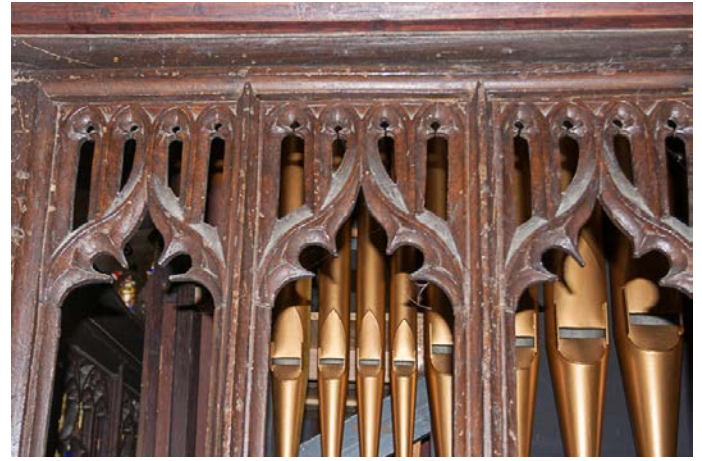
Detail of tracery on south chapel screen

with perpendicular panel tracery. Tracy has convincingly compared this tracery to the south elevation of the upper storey of the watching chamber at St Albans Cathedral. In an article in the *Journal of the British Archaeological Association* he dates the majority of the watching chamber to 1370 and the south face to 1420 following a fire. He thus dates this screen to 1420 also. However, whilst his dating of the majority of the watching chamber to 1370 is made by comparing its style to firmly dated monuments, his dating of the south face is general and impressionistic. He says,

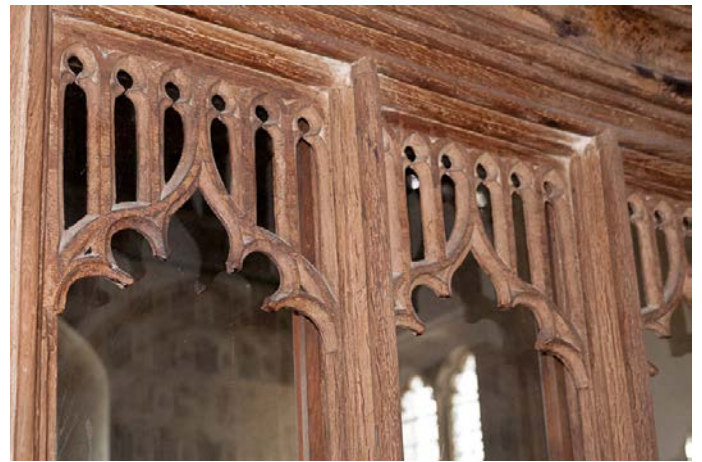
St Mary's Church, Ewelme, Oxfordshire: tracery on parcloze screen

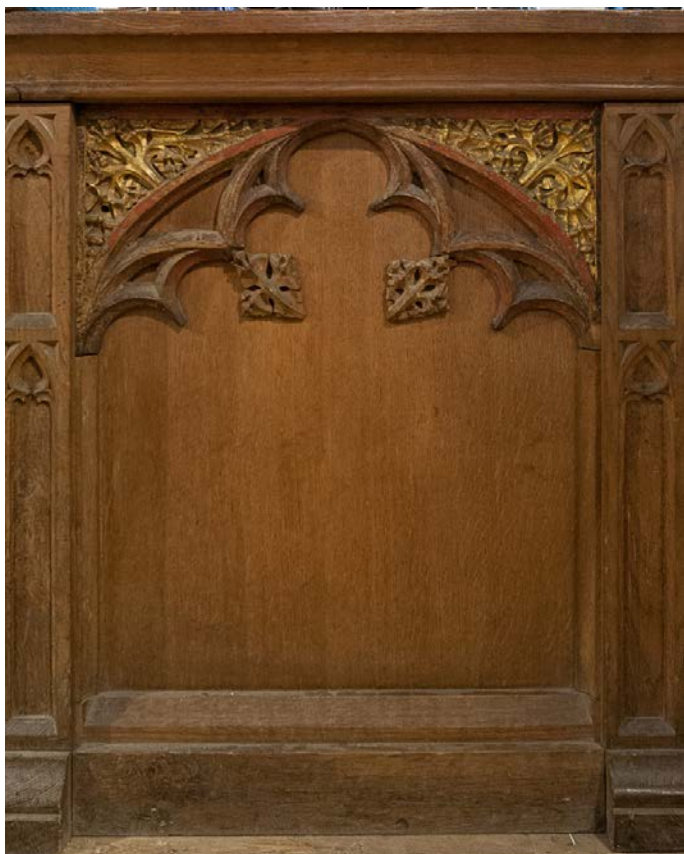
*Detail of desk frontal*

This tracery is clearly an attempt by a later wood-worker to match the style of the six existing tracery heads now incorporated into Nicholson's desk fronts. The reason why this was necessary is unclear. As with the desk fronts the design consists of a four-centred arch, trefoil cusped and sub-cusped, though here the arch has straight sides. Again, as with the desk fronts the spandrels are filled with stylised foliage, but here carved in a very different and distinctive man-

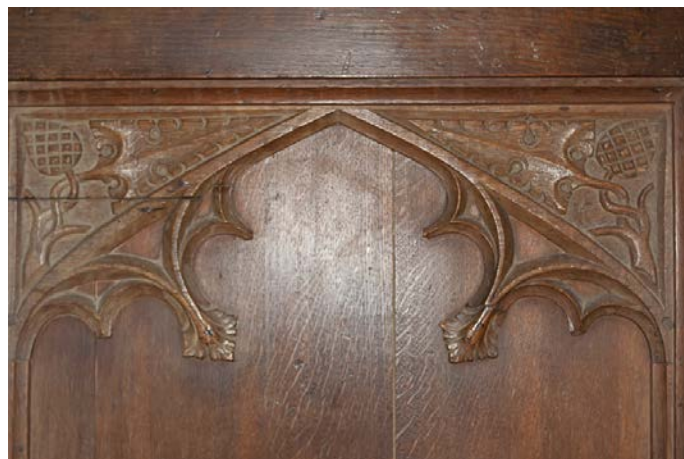
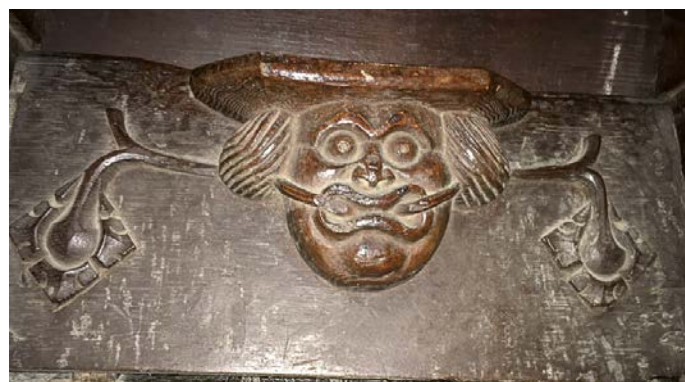
*Tracery on Lady Chapel chair above, with Green Man misericord below*

ner. The foliage appears to be intended to represent a vine with a bunch of grapes and stylised leaves. The vine has been pruned so that at each point where the branch forks one of the two stems has been cut. The significance of this will become apparent below.

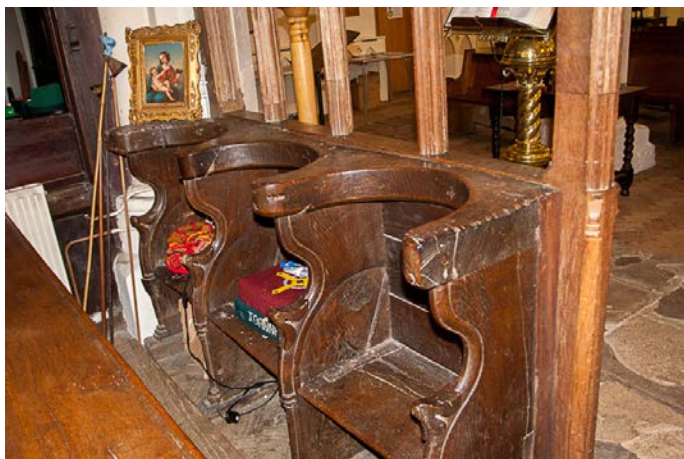
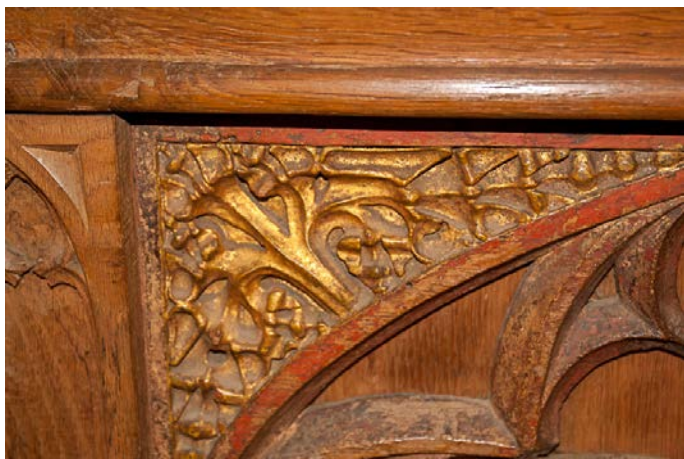
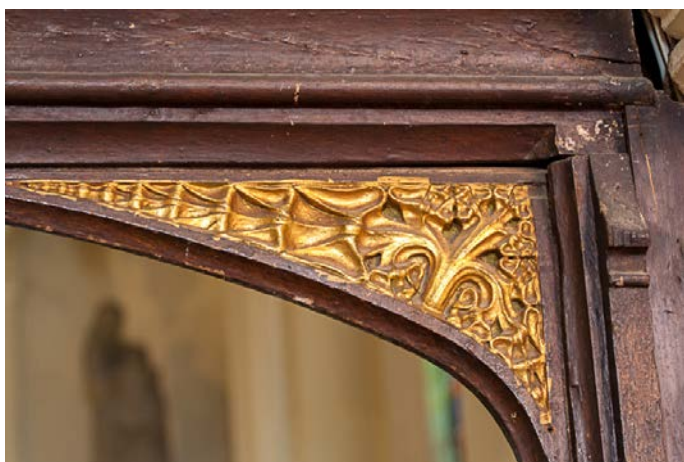
Above: i) three choirstalls, ii) spandrel on desk frontal compared with iii) spandrel on parclose screen

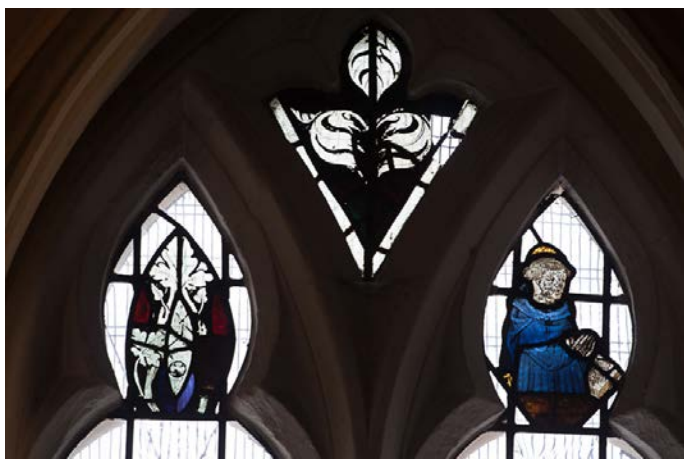
Below: fragments of medieval stained glass

What medieval stained glass survives is now in the south window of the Trinity Chapel. This consists of some fragments of foliage and a fifteenth-century monk in a blue habit praying before an open book with the edges of the pages picked out in silver stain. In 1804 Oldfield recorded two shields bearing pre-1340 royal arms. These appear to have been lost.

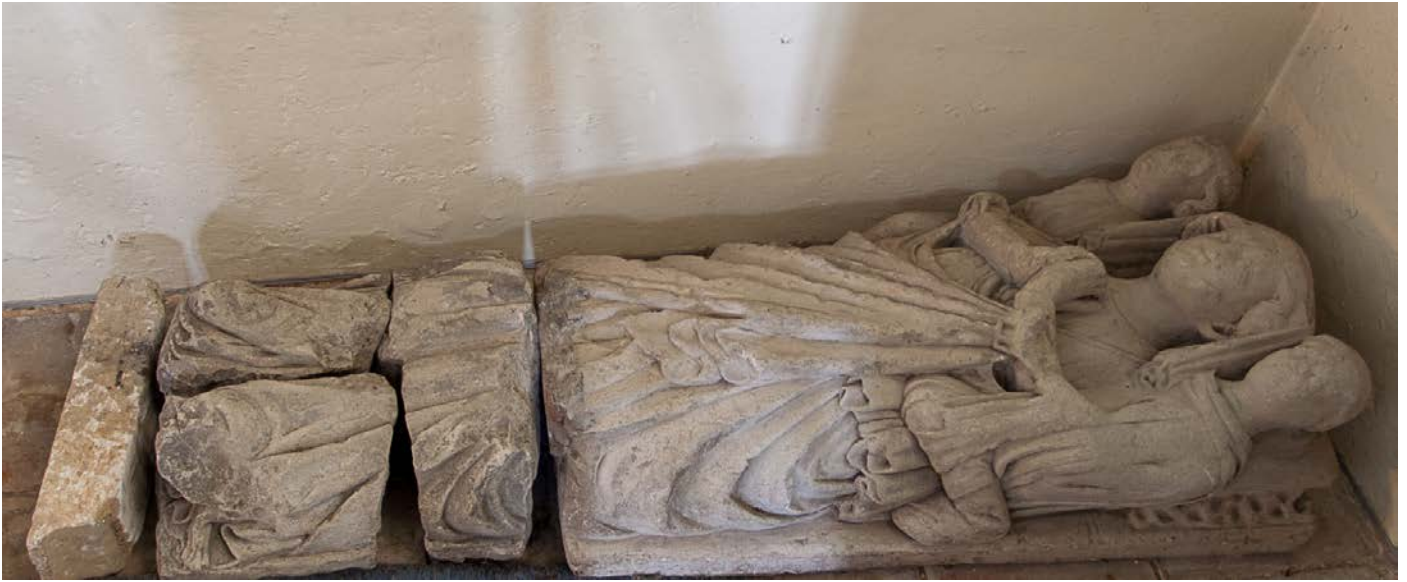
The thirteenth-century font stands in the westernmost bay of the nave before the tower arch. It consists of a

columnar stem with four attached shafts supporting a large square 'bowl'.

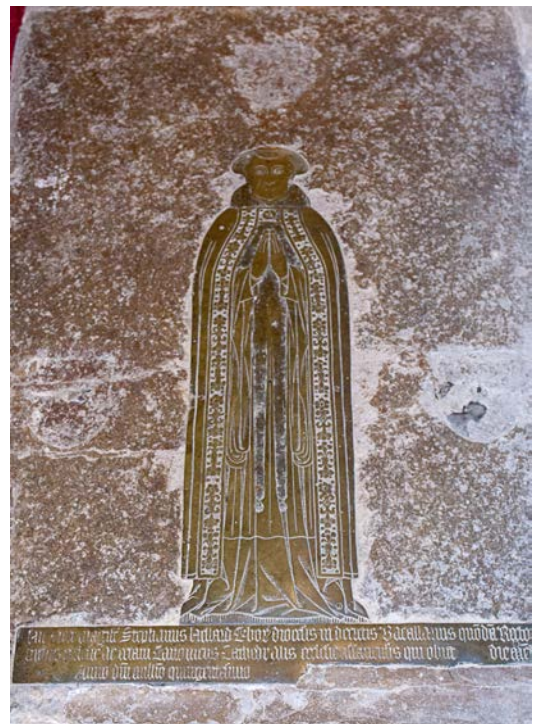
In the Lady Chapel lies the damaged effigy of a noble woman dating to c1300 (above). This high quality piece of sculpture is deeply undercut and the figures beside her head depict a monk and the other a secular figure supporting her elbows, perhaps family members(?). In the chancel, north of the altar is preserved the brass of Stephen Hellard, rector 1472–1506 wearing a cope, his hands clasped in prayer (right). At the entrance to the Lady Chapel is preserved a matrix that once held the brass of a couple with their children as weepers and four heraldic shields (mid C15) and at the entrance to the chancel a black marble slab with inscribed cross (C13?).

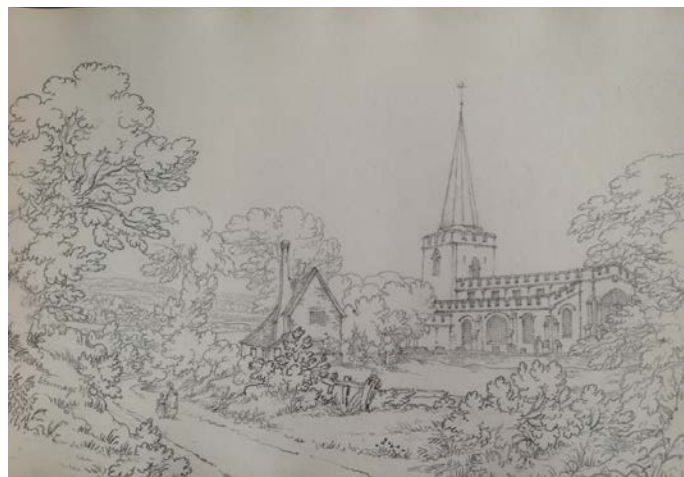
*Undated sketch of church before 1841 restoration (HALS DE/X837/1/58)*

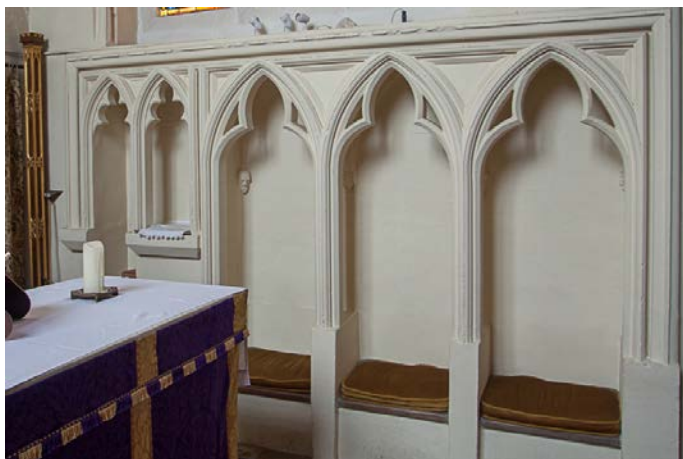
*The piscinas and sedilia uncovered in the 1841 restoration*

we can rely upon the design is very much open to question. The window has a segmental head internally and a square head externally. If the form of this sedilia and piscina can be relied upon, then these are in an identical style to the piscinas in the flanking chapels.

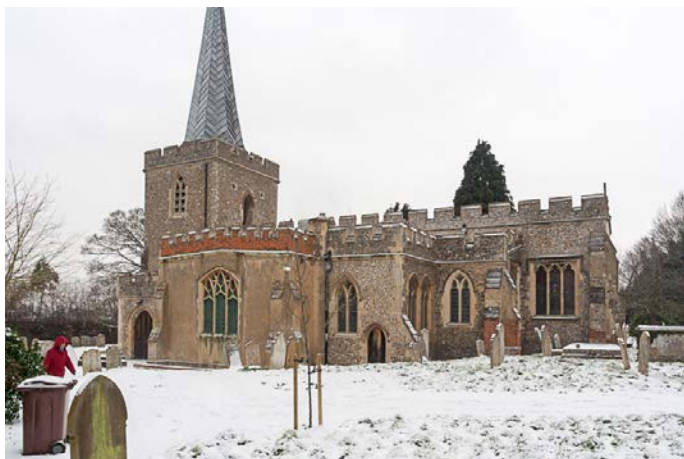
View of the church from the south-east showing the east end of Nicholson's additional aisle

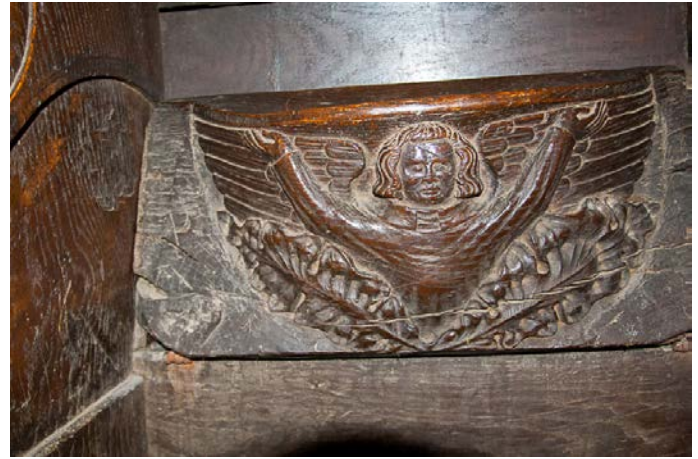
*Carved angel misericord*

The choir stalls date from the fourteenth century, and were modified in the sixteenth century. We cannot say with certainty that they were created for the church. We can say that they have been in the church since at least the sixteenth century. They are of **high significance** not only as objects of intrinsic historical and aesthetic interest but also for what they can tell us about the way in which liturgical furnis-

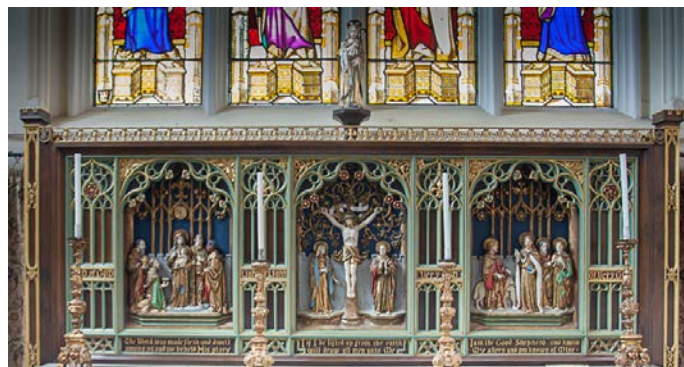
Nicholson's fine reredos carved by Guglielmo Tosi

furnishings and Tosi's skills as a carver of intricate detail. However even its setting could be argued to have been compromised in 1994 by bringing the table forward, turning the curtained side-wings through 90 degrees to lie flat against the chancel wall and removing the riddel posts, reported to have come from Chester Cathedral where Revd Blomfield was a Canon.

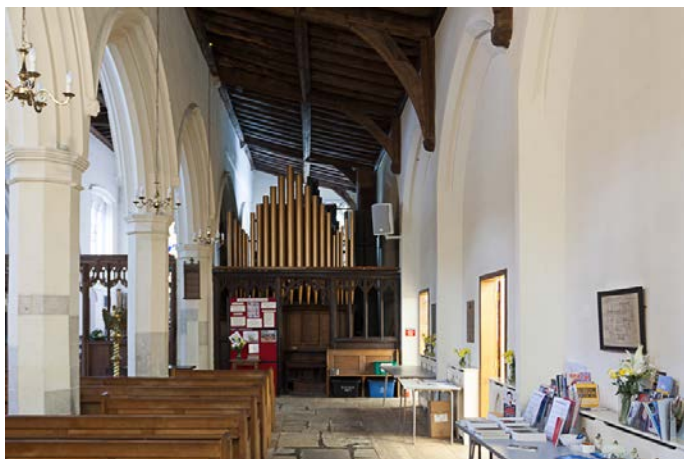
*South aisle showing how the parish room has closed off Nicholson's additional aisle and the organ has obscured the chapel*

The creation of the parish room led to the removal of 'Mouseman' pews in Nicholson's new aisle, so the **high significance** of Thompson's scheme has also been degraded.

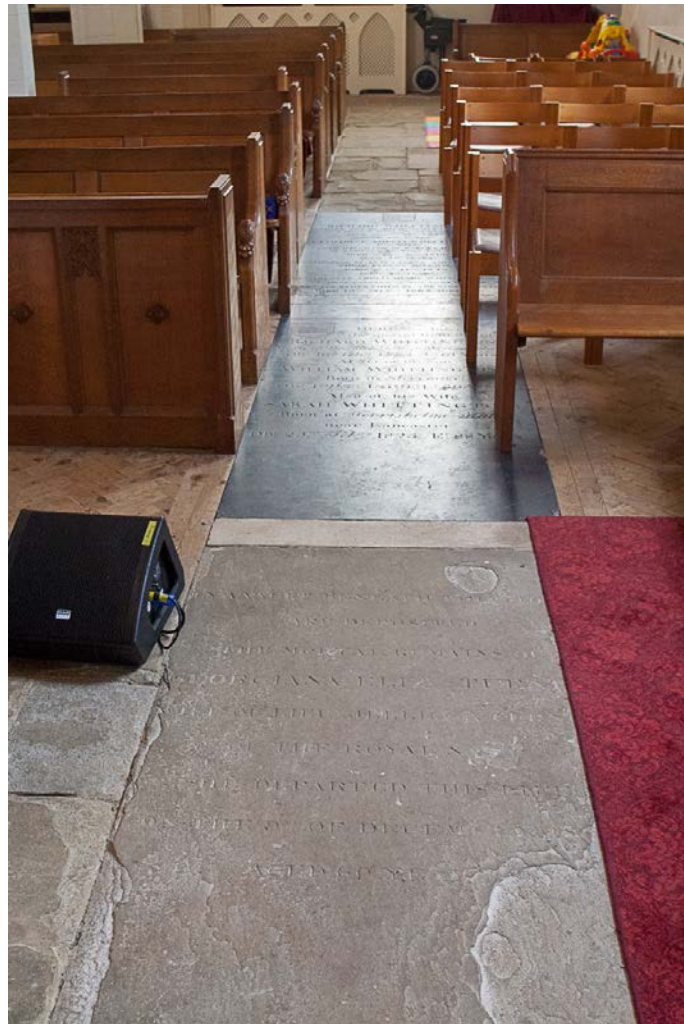
*North aisle floor with 'Mouseman' benches on wood-block flooring installed by Nicholson either side of re-laid ledger stones and slabs.*
